# *The* **MORRIS**

**11 9 h.p. & 14/28 h.p.**

**SERVICE  
INFORMATION**

*Published by*  
**MORRIS MOTORS LIMITED**  
COWLEY, OXFORD

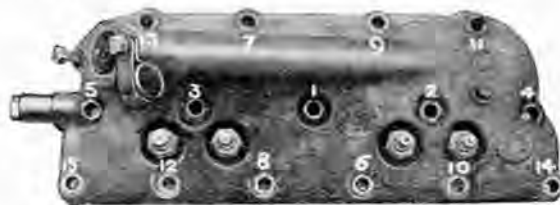
The order in which the cylinder head holding down nuts should be loosened and tightened up.

*Note.*—When tightening up the cylinder head nuts on reassembling the engine the same sequence should be observed, viz. work from the centre outwards.

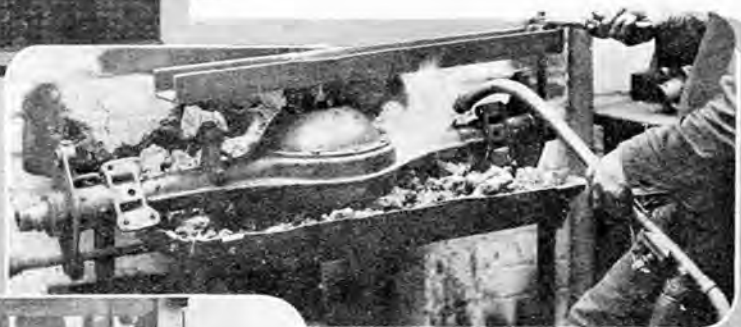
These three photographs show the best method of dealing with damage to the rear axle casing. Such is the infrequency of the task—it only becomes necessary after a car has been run into from the rear—that many Works' managers have little experience of carrying out the work expeditiously.

*On no account is the axle case to be heated above a very dull red.*

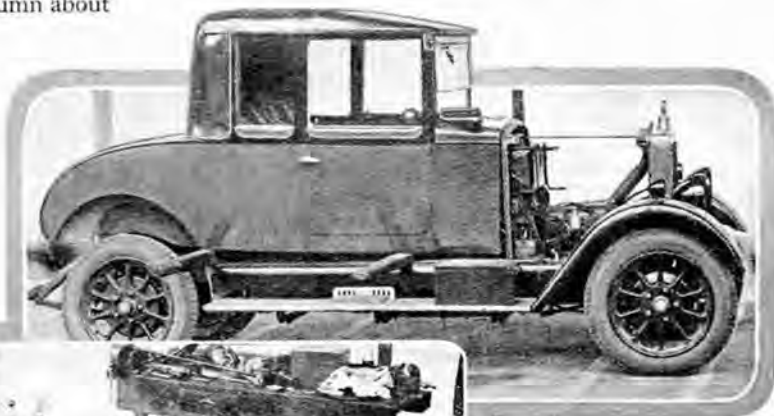
on to a power unit carrier (as per Figs. 2 and 3, or use a suitable stand), but keep the lifting chain taut. Then remove engine tray clips from frame and engine bearer arm bolts.

11. Suspend rear end of frame sufficient to take the weight and remove all bolts holding front wings and running-board brackets to frame, and lower complete assembly to floor.

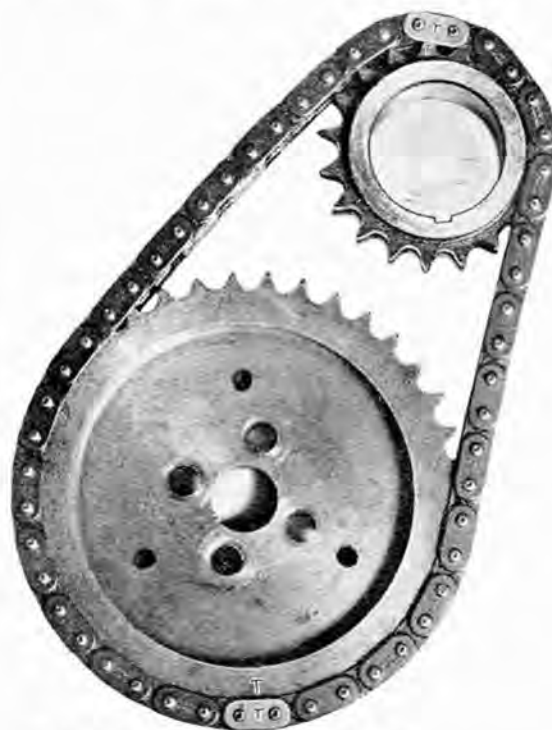
Here is shown the correct position for the sprockets and chain to ensure correct timing.

It will be found that a tooth on the crankshaft sprocket is marked with the letter "T." The crankshaft should be turned until this tooth comes to the bottom. Additionally, it will be seen that there are two bright links on the timing chain, and another tooth marked with the letter "T" on the camshaft sprocket.

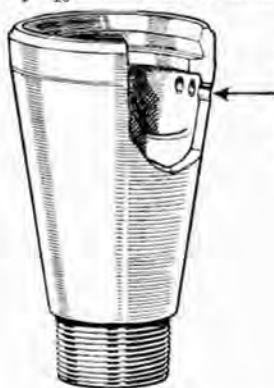
Three  $\frac{3}{16}$  in. dia. holes drilled at BACK of oil filler in position shown just below inner rib.

In the first place, in order to ensure adequate lubrication, it is essential to shorten the dipstick or oil level indicator by  $\frac{9}{16}$  in. This is best done by unscrewing the spring cover and cutting off the amount stated by means of a hacksaw. The thread should be re-cut by using  $\frac{3}{8}$  in. Whitworth adjustable dies, although if these are not available,  $\frac{5}{16}$  in. Whitworth will be found suitable. A little solder may be used to prevent the spring and cover from unscrewing in service.
